TECHNICAL REPORT
TR-NAVFAC-EXWC-EV-1706
DECEMBER 2016

**Final Report : Innovative Acoustic Sensor Technologies for
Leak Detection in Challenging Pipe Types**

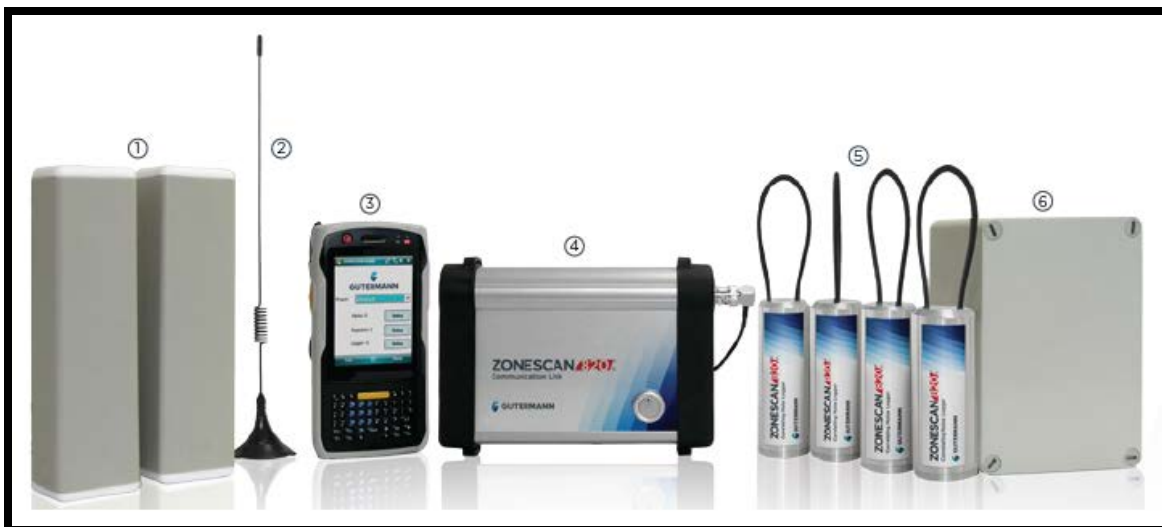
The ZoneScan Alpha acoustic logger sensor system for continuous monitoring is shown in Figure 2-2. Table 2-2 summarizes the primary components, along with their respective function. System components include: (1) radio repeater modules to send data to a centralized computer processing system; (2) extended antenna (optional to transmit data over longer distances); (3) personal data assistant (PDA) for system setup; (4) communication link for system setup; (5) ZoneScan acoustic sensors; and (6) ZoneScan Alpha Com Link. The system also relies on data management, processing and display capabilities provided by a personal computer system operated by the user and Gutermann's centralized server that provides data processing capability. The sensors are permanently or temporarily installed on valves or fire hydrants at targeted areas of the potable water distribution system. The sensors are easily attached via a magnet on the bottom of each sensor. The sensors can be connected via radio transmission or they can be integrated into an existing AMI network.

Figure 2-2. ZoneScan Alpha System Components (Courtesy of Gutermann)

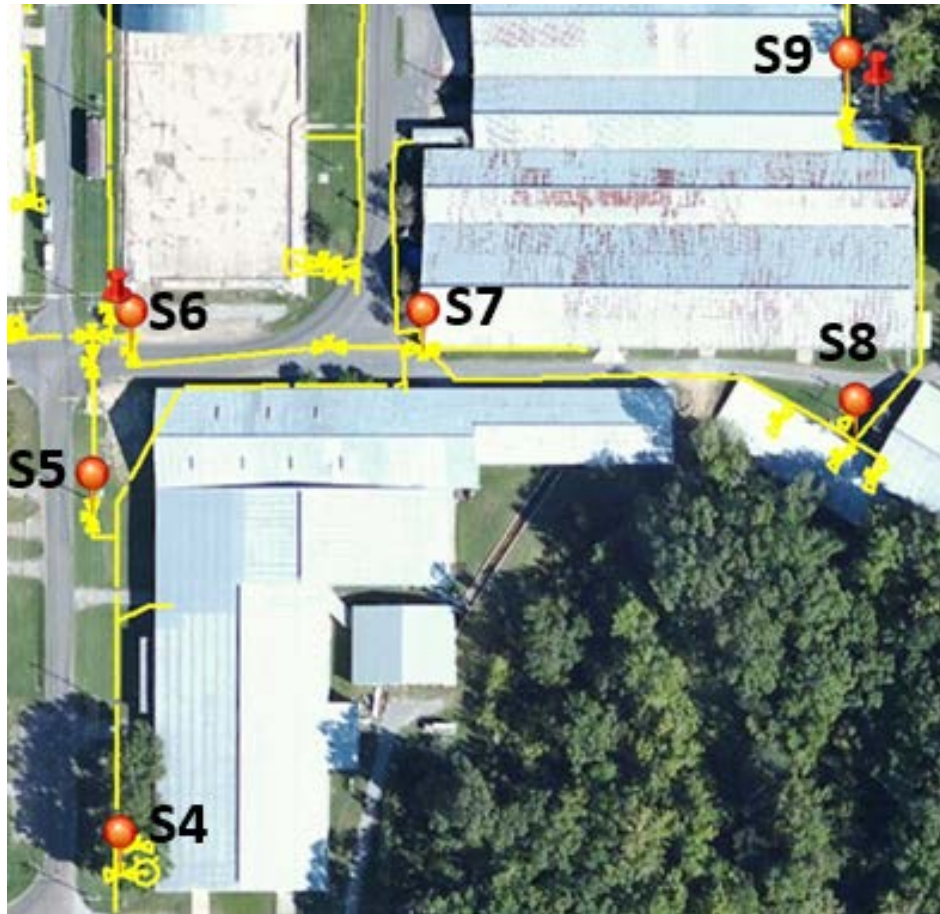
Figure 6-3. Map of Area B ZoneScan Alpha Sensors (from ESRI ArcGIS, 2015)

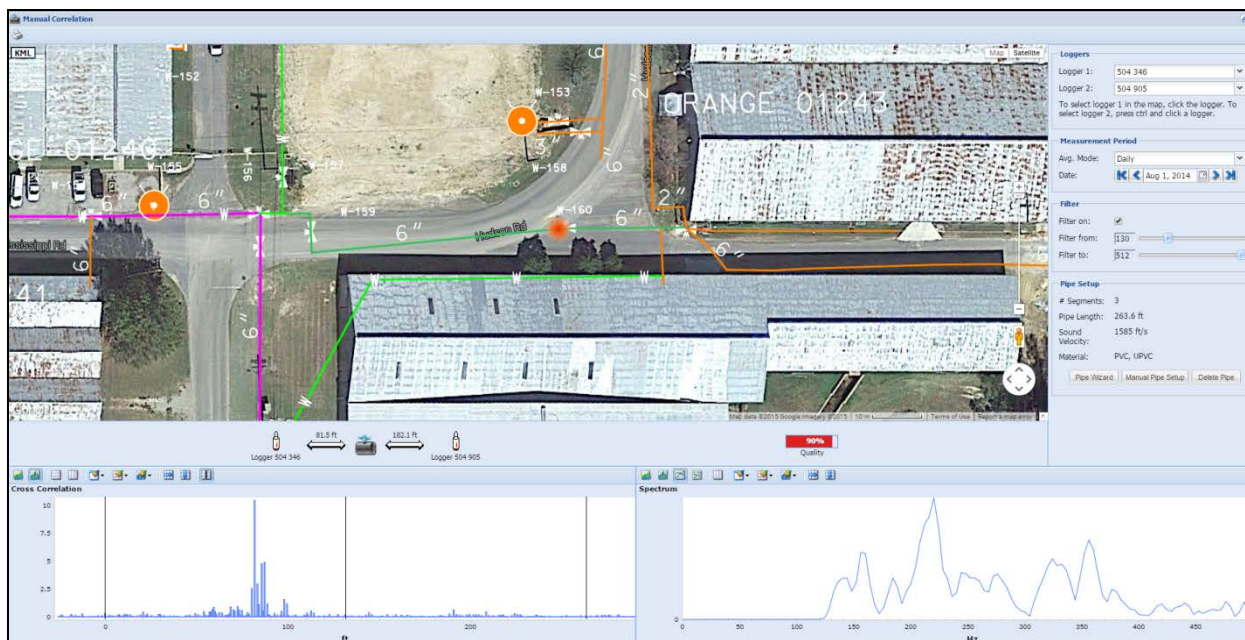
Figure 6-4. Manual Correlation between Sensors 6 and 7 in Area B on August 1, 2014
